NAVY EXPERIMENTAL DIVING UNIT PANAMA CITY FLA EVALUATION OF KMB-10 BANDMAS(.(U) SEP 76 C 6 GIBSON NEDU-11-76

KMB-10 BANDMASK

4. TITLE (and Subtitle)	5. TYPE OF REPORT & PERIOD COVERED							
Evaluation of KMB-10 Bandmask	Final							
	6. PERFORMING ORG. REPORT NUMBER							
7. AUTHOR(e)	B. CONTRACT OR GRANT NUMBER(a)							
HTC(DV) C.G. GIBSON								
1000 100

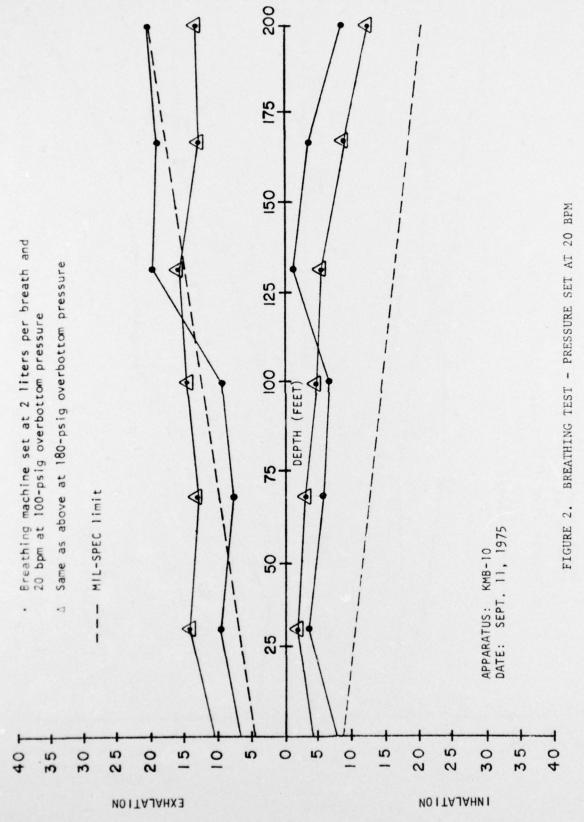
All test data were evaluated on the basis of the performance limits given in MIL-R-24169A governing single-hose regulators. The results are shown graphically in Figures 2 and 3.

The measured exhalation pressure resistance levels were unacceptable at all depths and pressures tested except for 66 and 99 feet of sea water at 20 bpm. In all other tests, the exhalation pressures were outside the limits specified. The exhalation resistance was also outside the specified limits at 35 bpm, a rate used only for heavy work and for short periods of time.

Inhalation pressure, at 35 bpm and 100-psig overbottom pressure, was outside the specified limits from 53 fsw. Only at 20 bpm could the inhalation readings meet specification requirements.

For the KMB-10 Bandmask to be accepted for service use or as a replacement for the KMB-8 or KMB-9 models, it must perform within the limits given in MIL-R-24169A to 200 fsw. As the KMB-10 failed to perform as specified, it is not recommended for Navy approval.

With some modification, the KMB-10 could probably be made to perform within specified limits. If U.S. Divers modify the KMB-10 Bandmask, however, further testing is recommended.

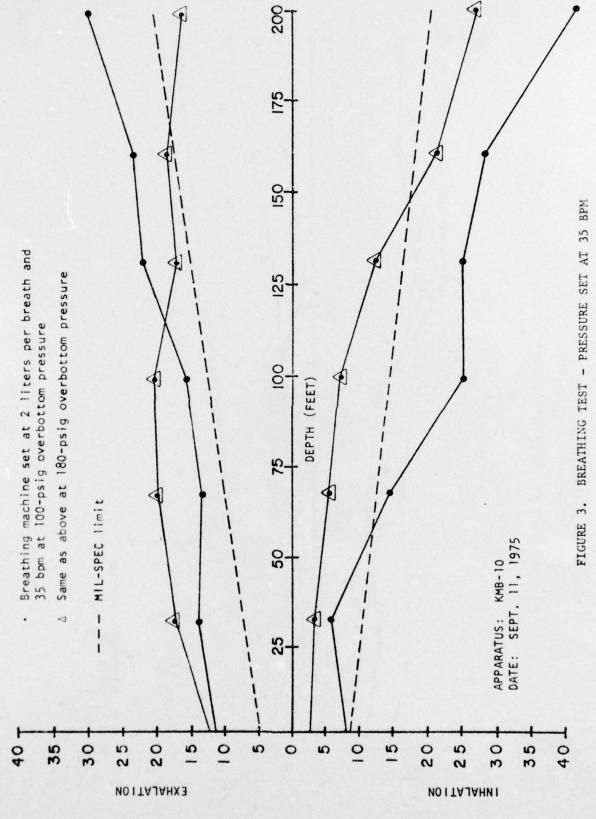
For record purposes only the breathing test was conducted at 35 bpm, using 2-liter volume both at 100- and 180-psig overbottom pressure (see Figure 3). Under these test conditions, the KMB-10 Bandmask performance was totally unacceptable.

At 35 bpm and 180-psig overbottom pressure, inhalation pressure was acceptable only to a depth of 150 fsw.
